**Guildhall Chambers
Broad Street
Bristol**

Archaeological Evaluation and
Historic Building Recording

CA Project: 4728
CA Report: 14106
OASIS ID: Cotswold2-173344

May 2015

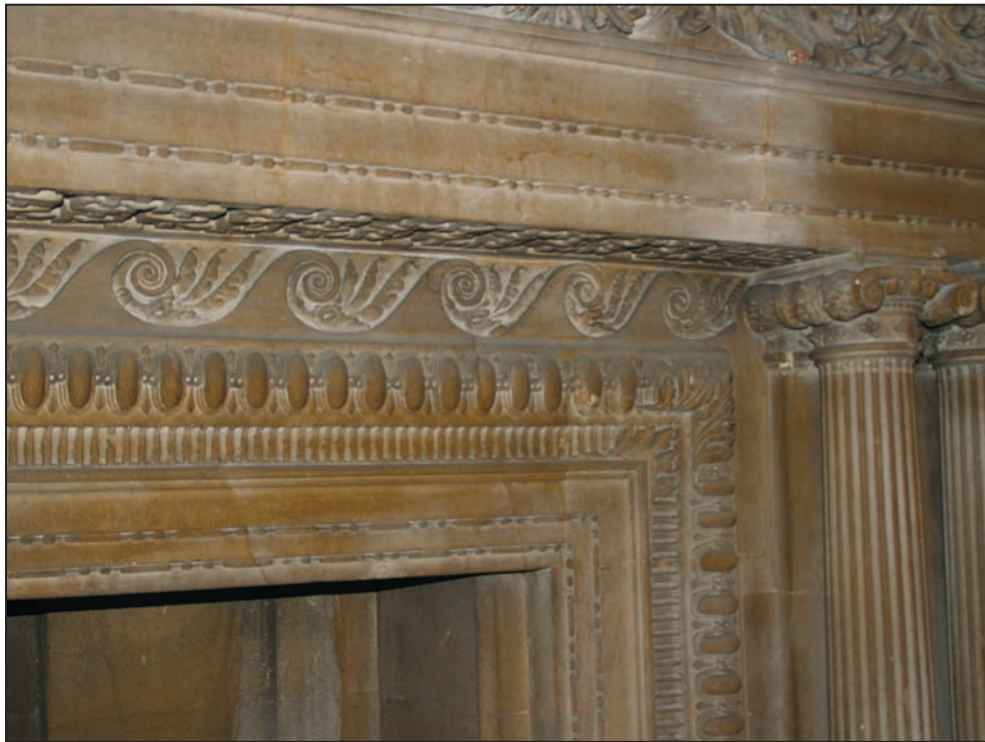
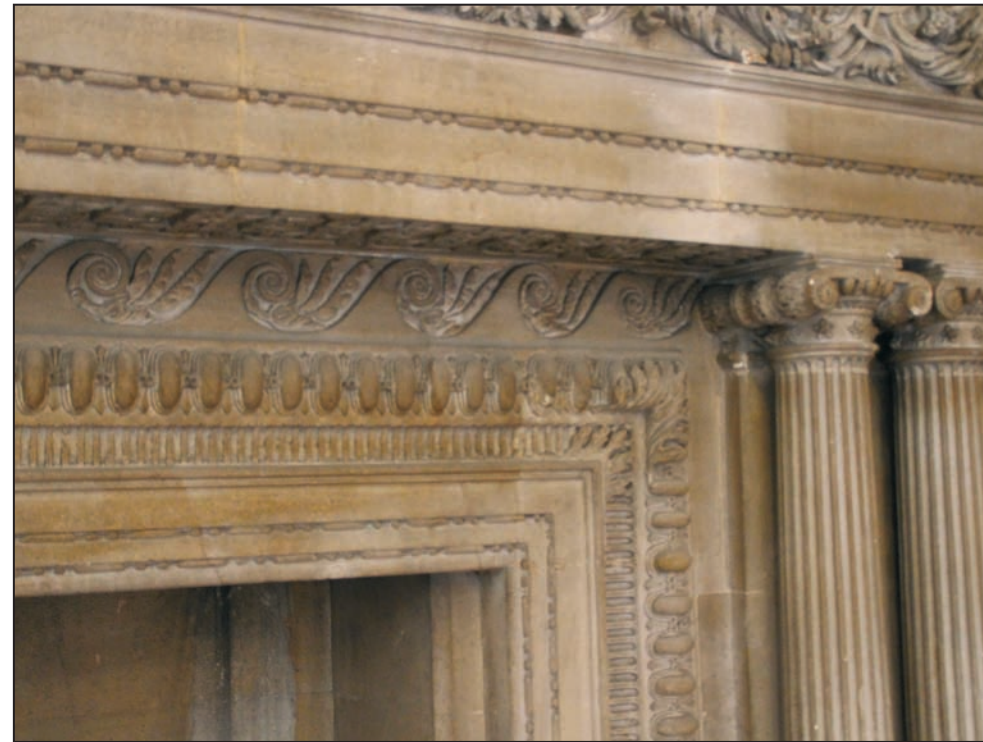
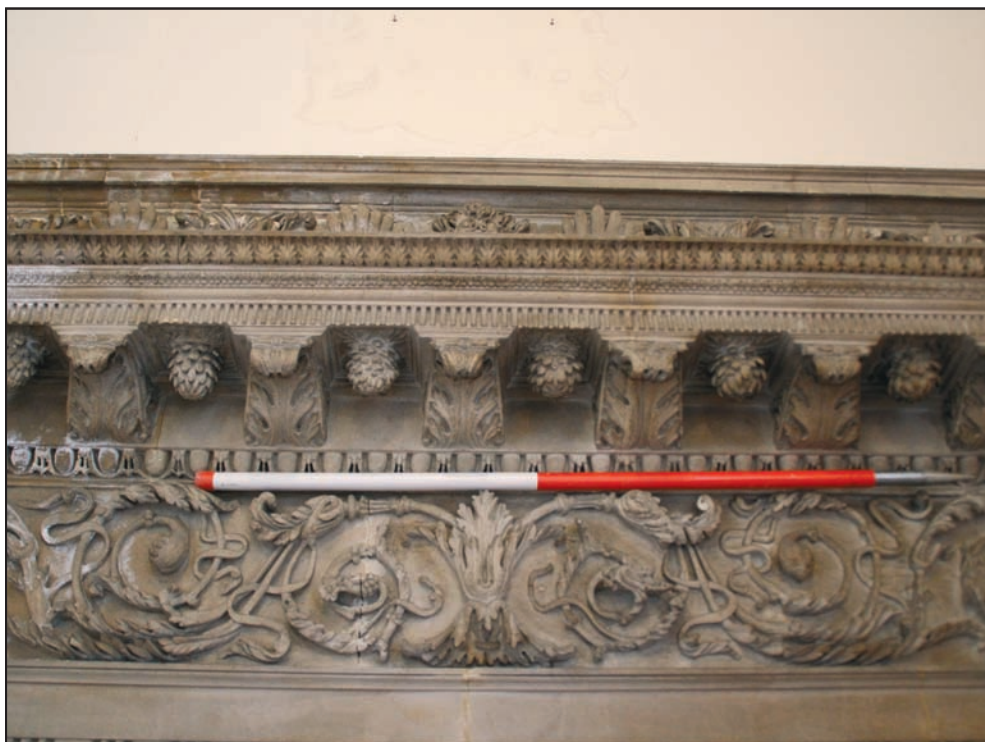
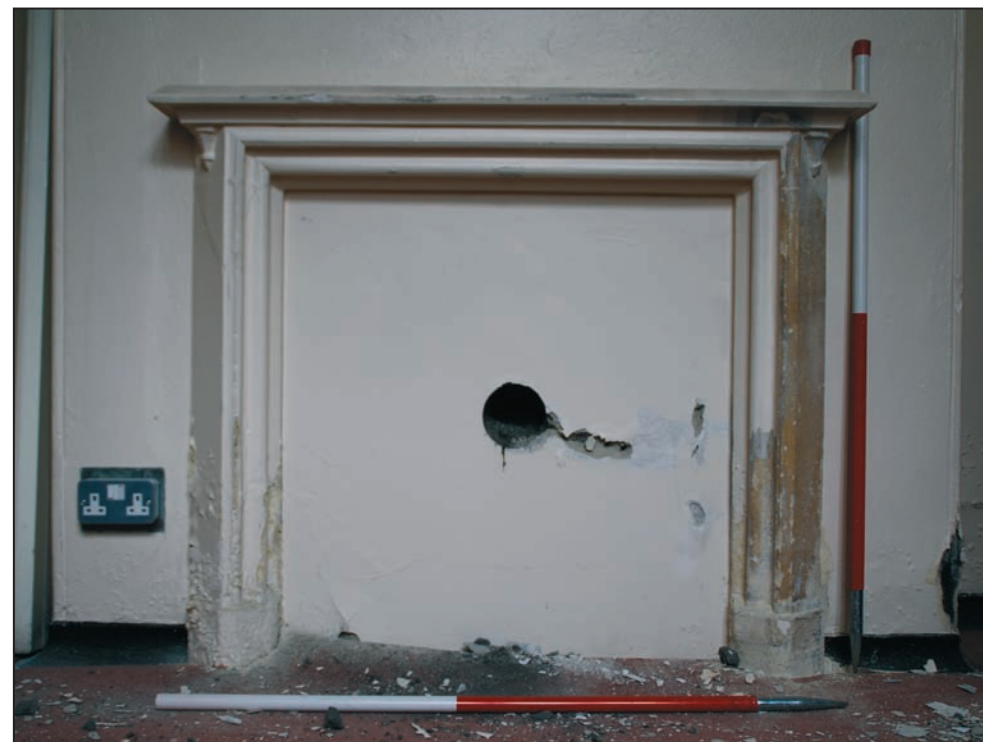
- 27 G5. Detail of top right of architrave of fireplace, flash. JPEG 1745.
- 28 G5. Detail of top right of architrave of fireplace. JPEG 1746.
- 29 G5 detail of entablature. Scale 2m. JPEG 1748.
- 30 Poss 16th C chimneypiece in G4. Scales 1m. JPEG 1794

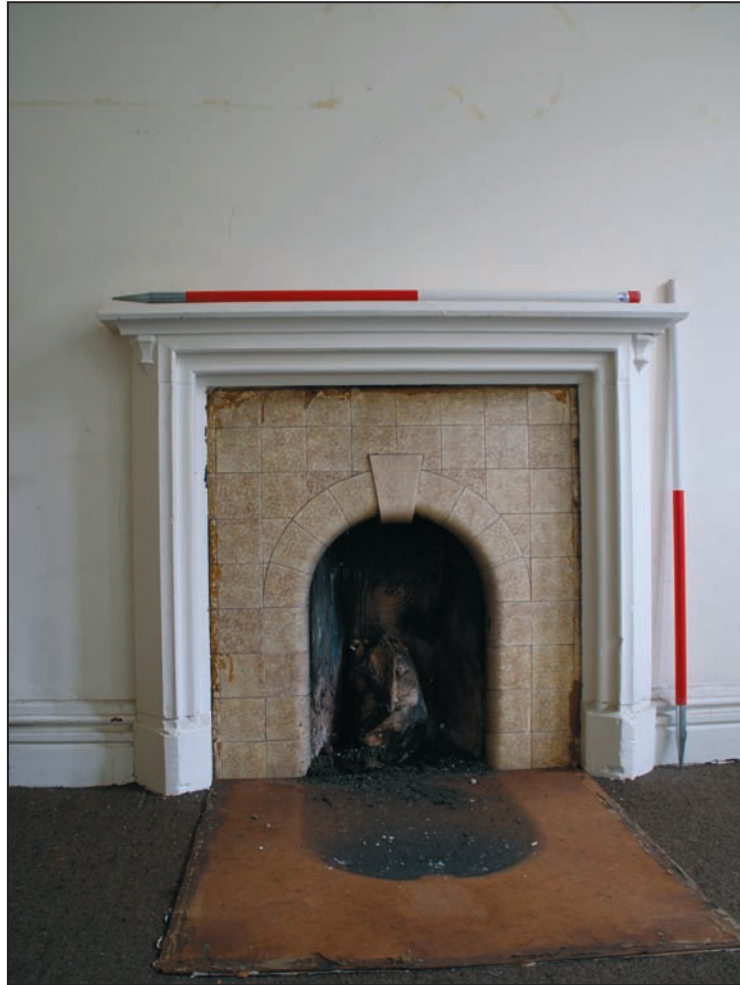
35 Chimneypiece in 2.5 identical to that in G4. 1930s-50s tiles. Scales 1m. JPEG 1754.
